REPORT NUMBER: 201-MGA-2003-001

**SAFETY COMPLIANCE TESTING FOR FMVSS 201
RIGID POLE SIDE IMPACT TEST**

Honda of America Manufacturing, Inc.
2003 Honda Accord 4 door
NHTSA NUMBER: C35301

**PREPARED BY:
MGA RESEARCH CORPORATION
5000 WARREN ROAD
BURLINGTON, WI 53105**

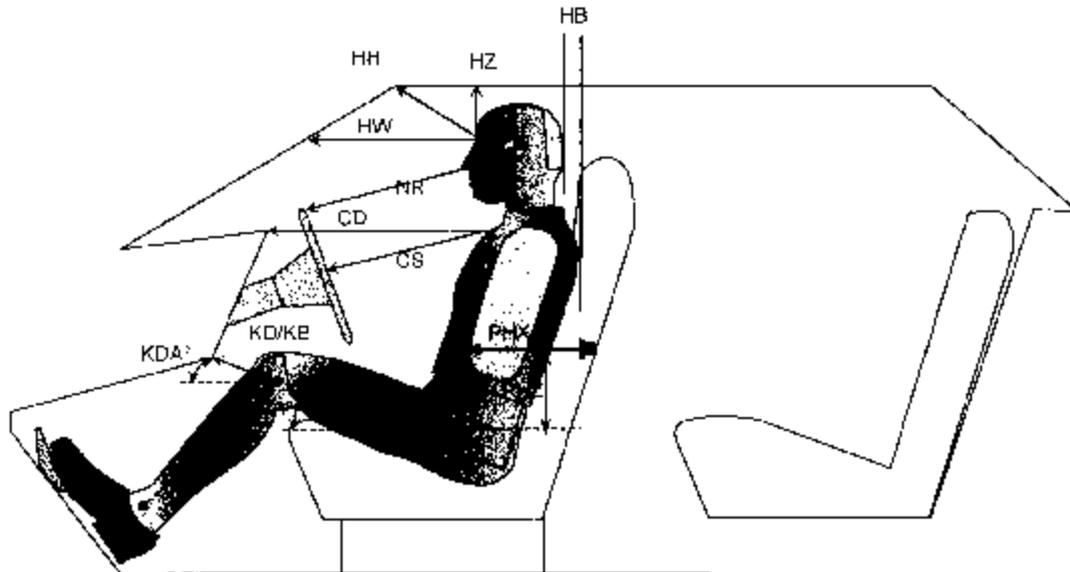
Driver Code	Measurement Description	Driver	
		Length(mm)	Angle(°)
HB	Back of Head to Back of Window @ Head CG	51	
HH	Head to Header	347	
HW	Head to Windshield	571	
HZ	Head to Roof	137	
NR	Nose to Rim	398	
CD	Chest to Dash	501	
CS	Chest to Steering Wheel	314	
KDL	Left Knee to Dash	211	0
KDR	Right Knee to Dash	172	0
PA	Pelvic Angle		23.9
PHX	H-Point to Striker (X-Axis)	220	
PHZ	H-Point to Striker (Z-Axis)	134

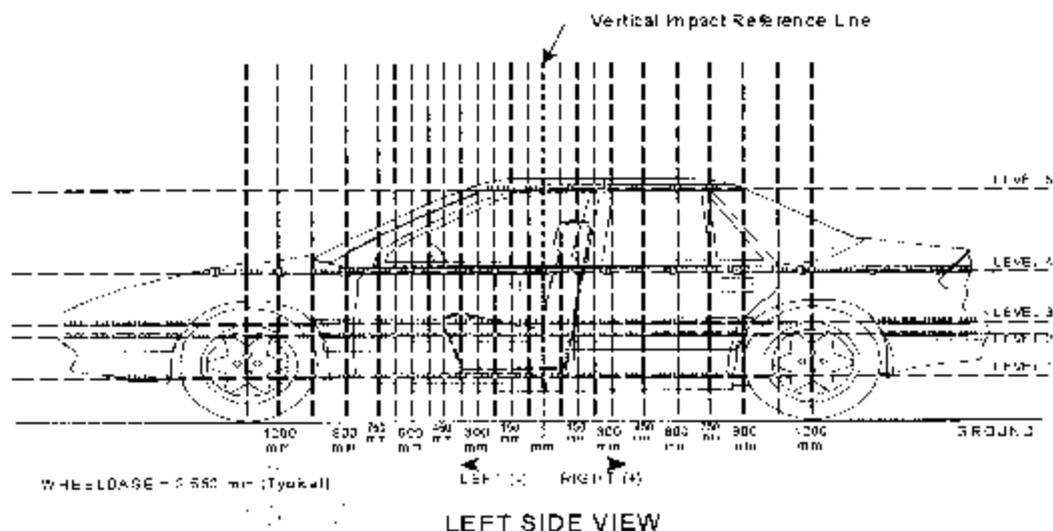
PRETEST AND POST TEST EXTERIOR PROFILE MEASUREMENTS

Measurements are taken with vehicle in the as tested condition.
 Measurements along the vertical 0 mm.

Level	Measurement Description	Units	Height Above Ground
5	Window	mm	1448
4	Window Sill	mm	990
3	Mid Door	mm	685
2	Occupant H-Point	mm	584
1	Sill Top	mm	372

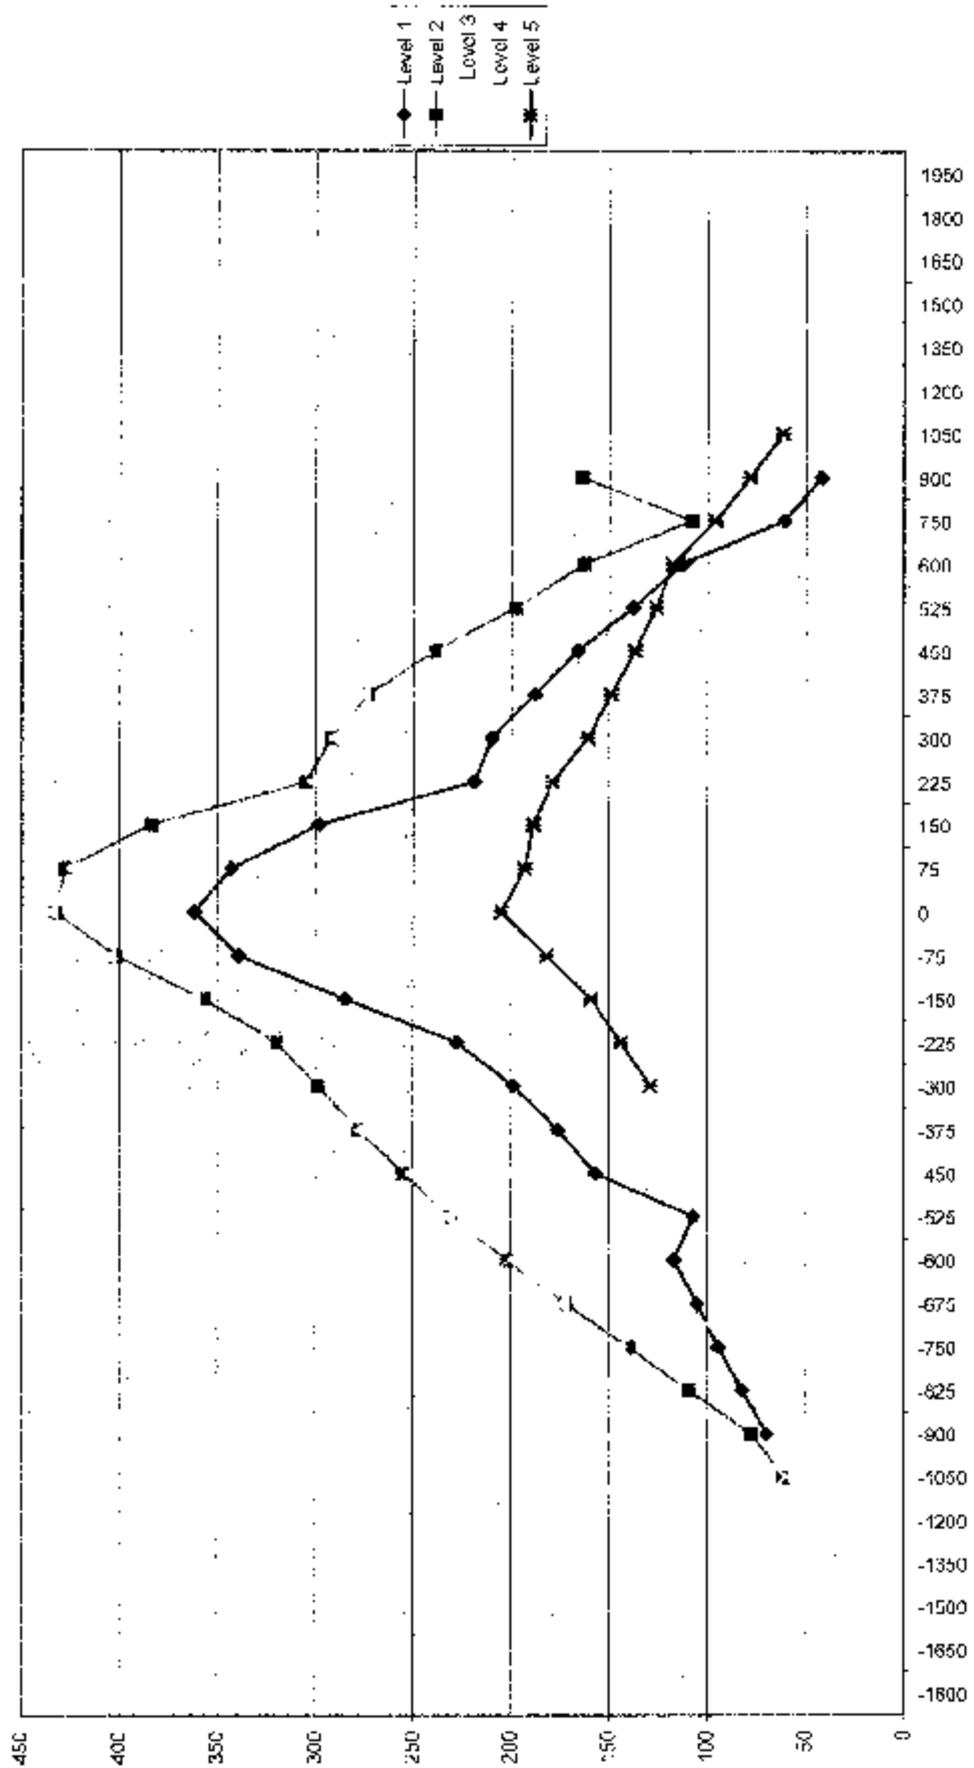
VEHICLE EXTERIOR CRUSH PROFILES

The test vehicle sustained a maximum static crush of 435 mm at level 3, at the vertical impact line. The driver SID/HIII, Serial No. 36, was calibrated just prior to this test. The SID/HIII's injury criteria are summarized as follows:

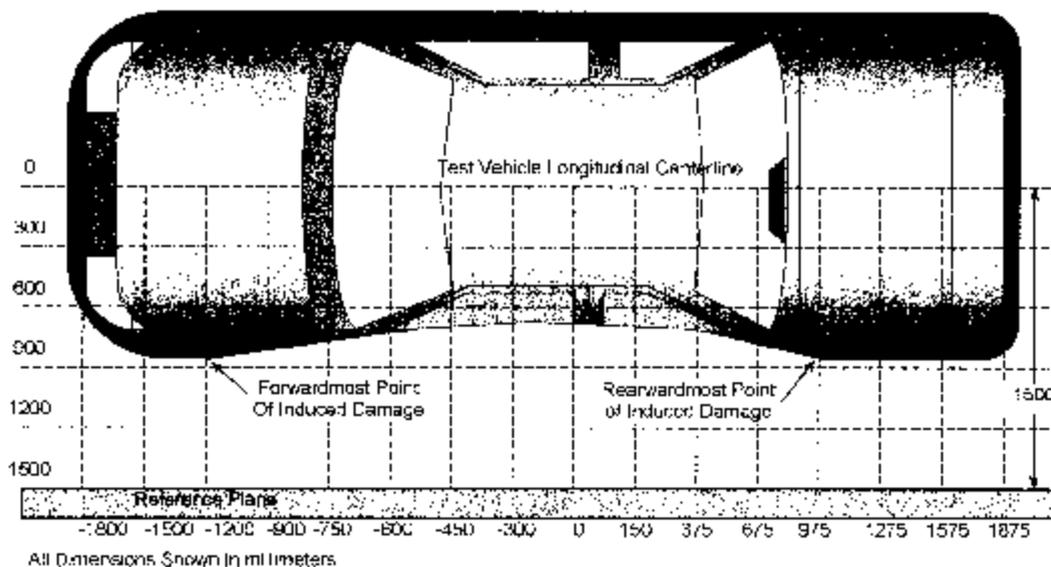
DATA SHEET NO. 10
VEHICLE DAMAGE PROFILE DISTANCES

TOP VIEW

Damage Profile Distances

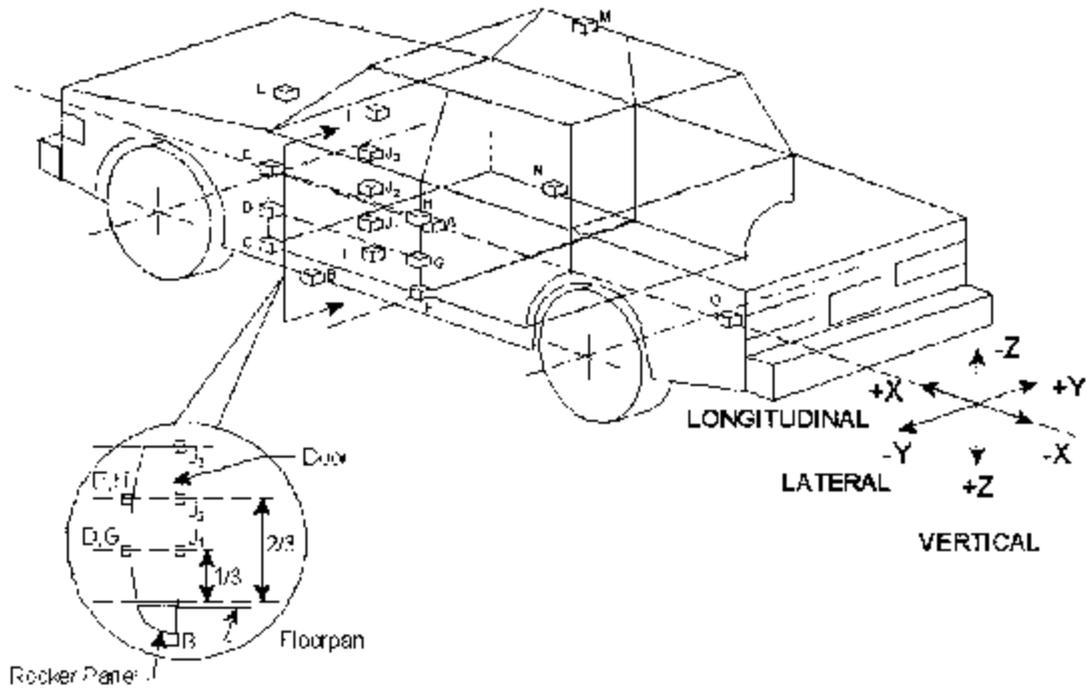
No.	Location
A	Vehicle CG
B	Left Floor Sill
C	A Pillar Sill
D	A Pillar Low
E	A Pillar Mid
G	B Pillar Sill
H	B Pillar Low
I	B Pillar Mid

No.	Location
L	Driver Seat
M1	Driver Door Rib
M2	Driver Door Pelvis
M3	Driver Door Knee
N	Engine
O	Firewall
Q	Right Floor Sill
R	Rear Deck

The test vehicle was instrumented with twenty (20) structural accelerometers. All data channels were recorded with a fully self contained on-board EME Data Acquisition System. The data was digitally sampled at 10,000 samples per second and processed per Section 12.2 of the Test Procedure.

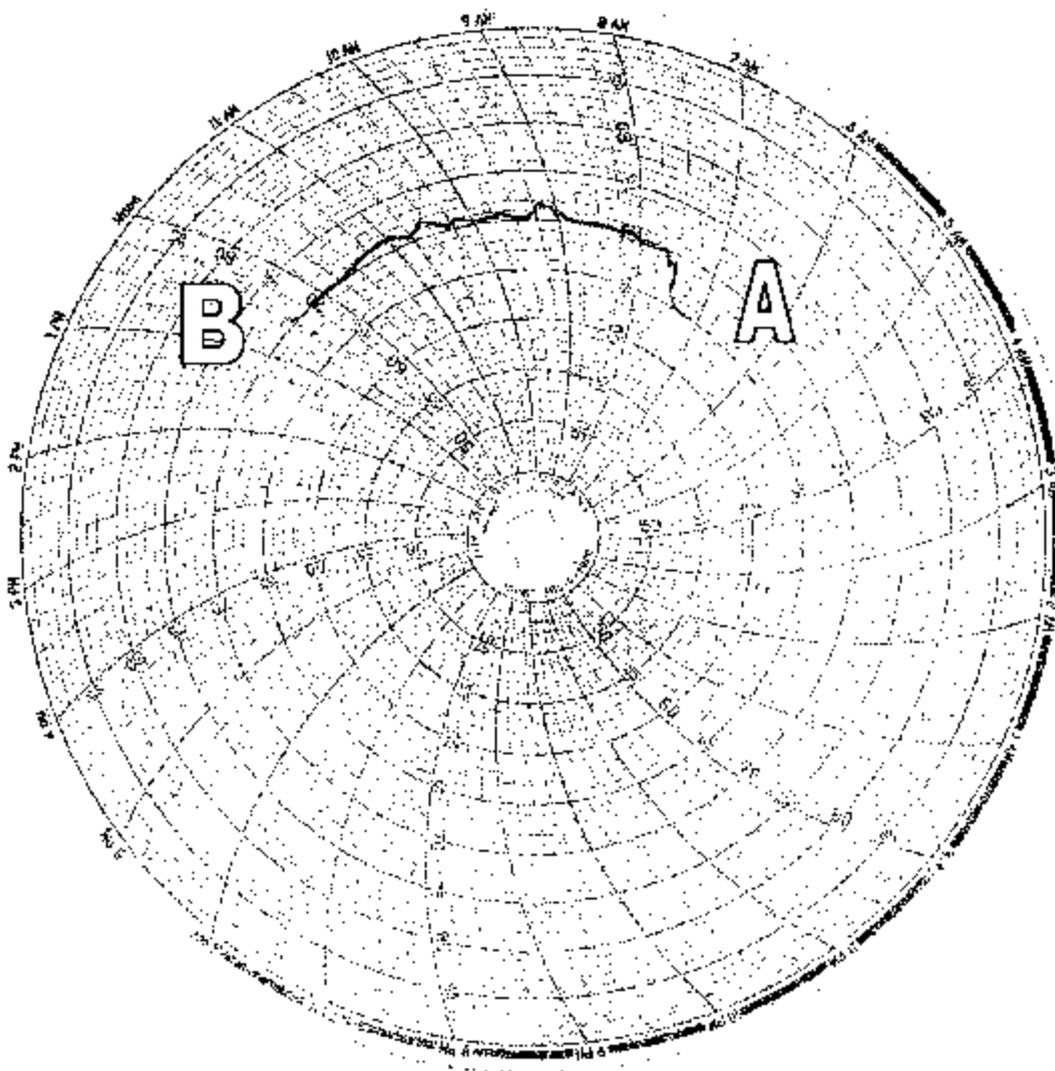
Vehicle and Dummy Temperature

A = Dummies installed in vehicle at 7:00 a.m.

B = Test conducted at 12:35 p.m.
